THE CITY OF COLD LAKE

NORTH ARENA

**CONCRETE ARENA FLOOR AND
HEADER / RETURN SYSTEM
ASSESSMENT**

July 8th, 2020

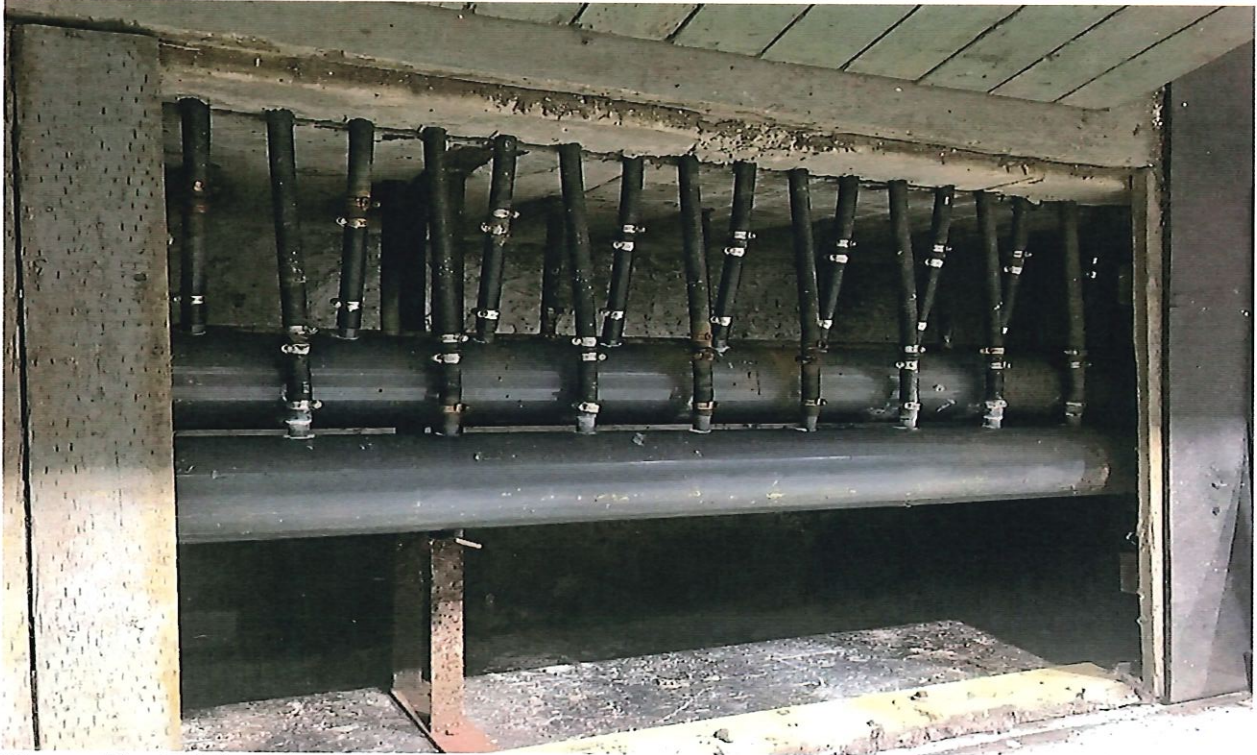
Picture #1 – PVC cooling headers in header trench seem to be in good condition

A common sign of a floor at the end of its life cycle is the detection of leaking rink pipe, rusted headers and/or rusted clamps. The cooling headers were replaced some time ago with PVC and these seem to be in good working condition. The heat floor headers below are steel and in an advanced state of rust (see pictures #1 & #2 for reference). It is likely that all the rink pipe have experienced wear over the years from the constant flow of brine, and there is a high probability leaks may develop (in the near future) due to the resulting thinning of the pipe walls. The u-bends looked to be in reasonably good condition though several clamps showed signs of rust (on header and return ends) ranging from low to advanced (see pictures #3 & #4); this is indicative of leaks at these locations. (The common way to mitigate leaks at the clamps is to install two clamps at each location and install them with gears on opposite sides of the pipe.) Leaks may have been detected at some point and sealed by changing or adding additional clamps. This action can mitigate leaks at the header and return ends, however there are limited options for the pipe within the slab. Should a leak occur within the slab it will saturate the concrete and de-bond the ice which will then look opaque. There are chemical products that can be introduced into the brine solution that can plug the leak from within as long as the leak is pinhole sized or smaller, however these do not always work and may only provide a few weeks or months of time before failure can be experienced again. Should failure be experienced again after the introduction of the chemical, it is unlikely that it can be resealed using this method and complete replacement of the slab will be required. It is not uncommon for rink pipe circuits to begin leaking (randomly) around the 40 year mark. Should this occur mid-season, it may take upwards to 3-4 weeks to: remove the ice, jackhammer out the suspect part of the floor, repair the pipe, patch the floor, allow a bit of cure time for the patch, cool the floor back down to operating temperature, and finally make new ice. If the leak is related to the age of the pipe and consequent thinning of the pipe wall, it may not be possible to splice at all and the season may be lost.

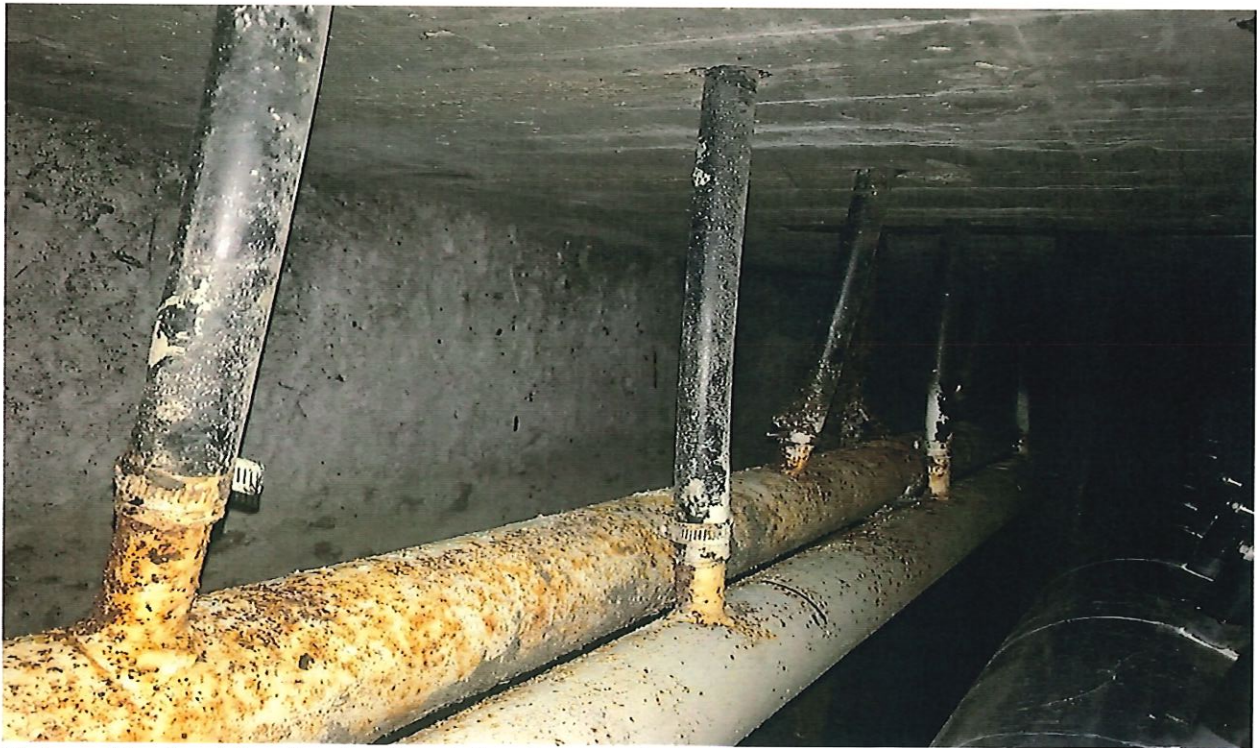
Picture #2 – Steel heating headers in header trench showing signs of rust

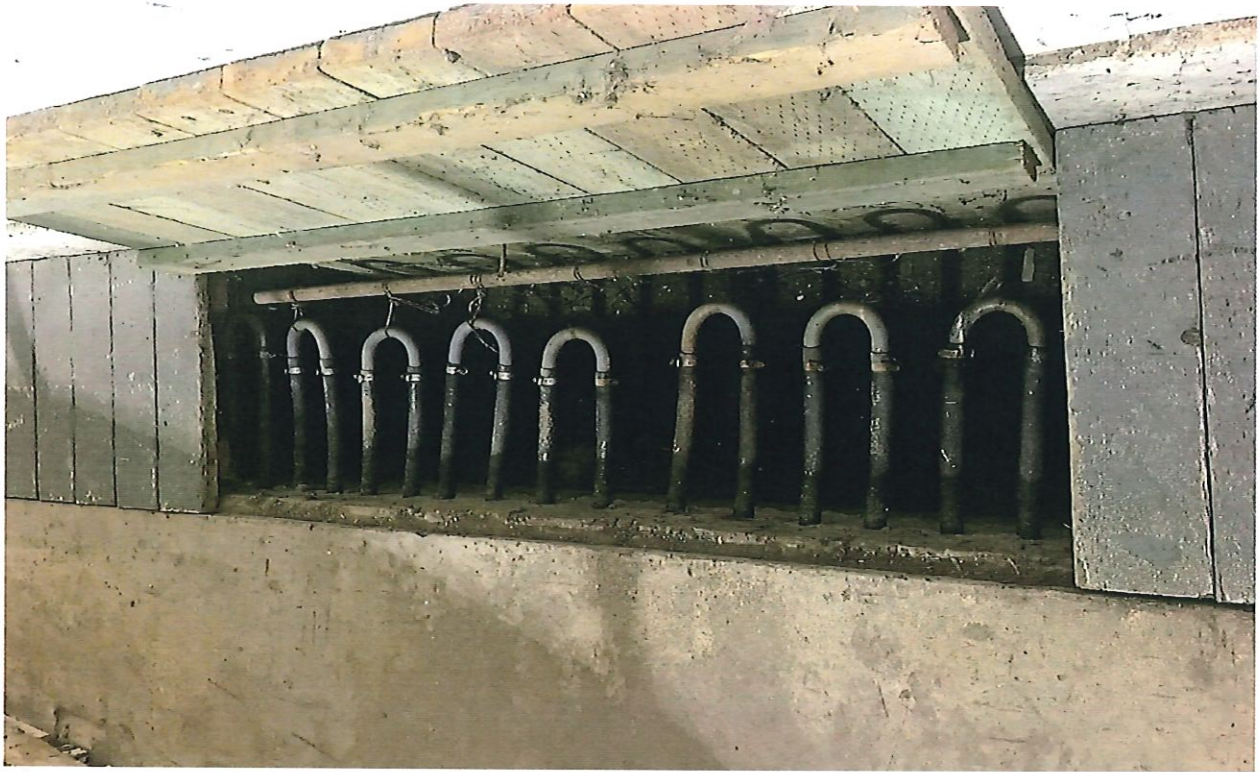
Picture #3 – U-bends in return trench, single clamps only with some signs of rust

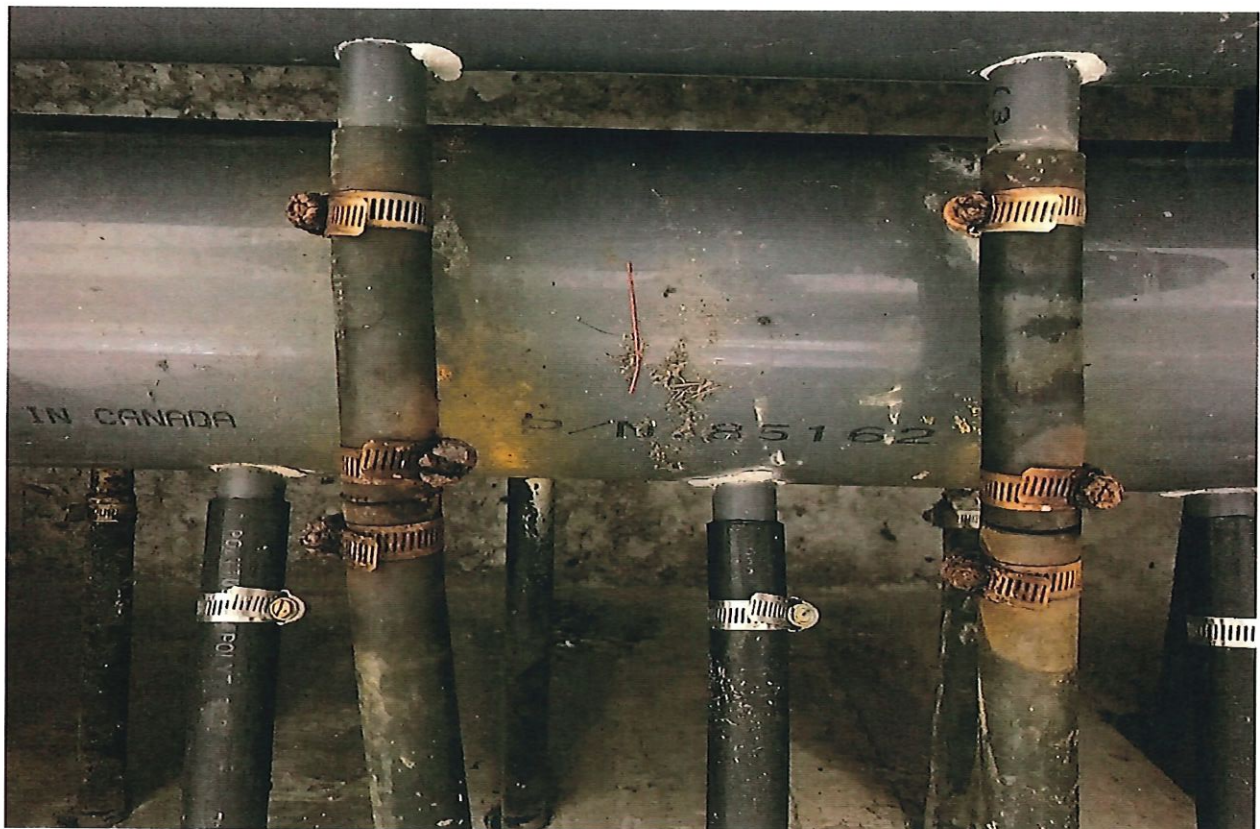
Picture #4 – Rusted clamps on header end pipe connections

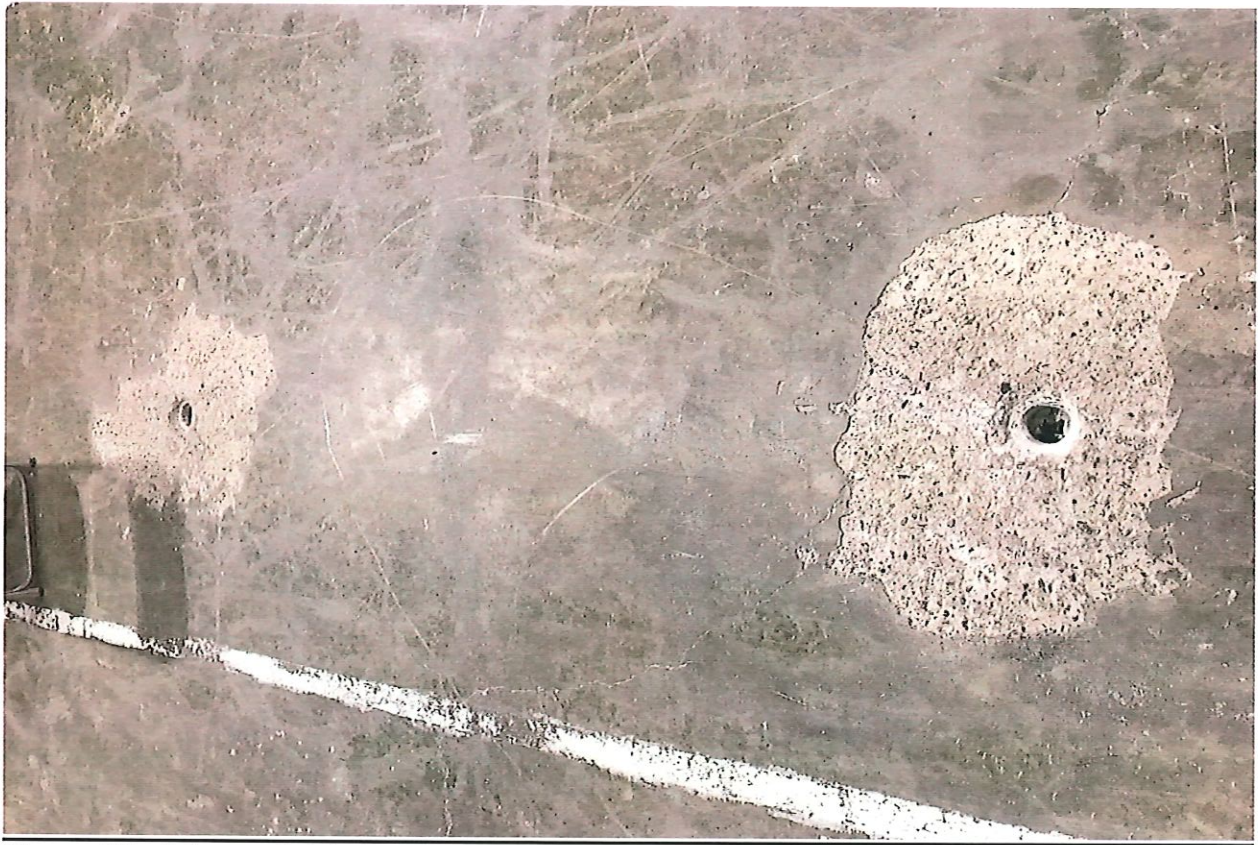
Picture #5 –Advanced slab deterioration around goal post inserts

The slab around the goal post inserts on one end is showing signs of accelerated deterioration (see picture #5). As the seal has been lost in this area, this is expected to continue as water pools in the inserts and freezes, thereby saturating the surrounding concrete and accelerating the deterioration. Additionally, the post anchors are nestled next to a cooling pipe, and as the anchors are drilled out (to remove ice build-up) over the years to make room for inserts the anchors thin with age. Eventually the drilling process wears through the anchor sidewall and the drill bit hits a newly exposed brine line thereby running the risk of causing a leak. This usually occurs during the operating season...for this reason (among others including minor league player safety concerns) the goal post anchors are typically reserved for Midget AAA and higher levels of hockey. Should the slab be replaced, we would advise against the installation of these inserts.

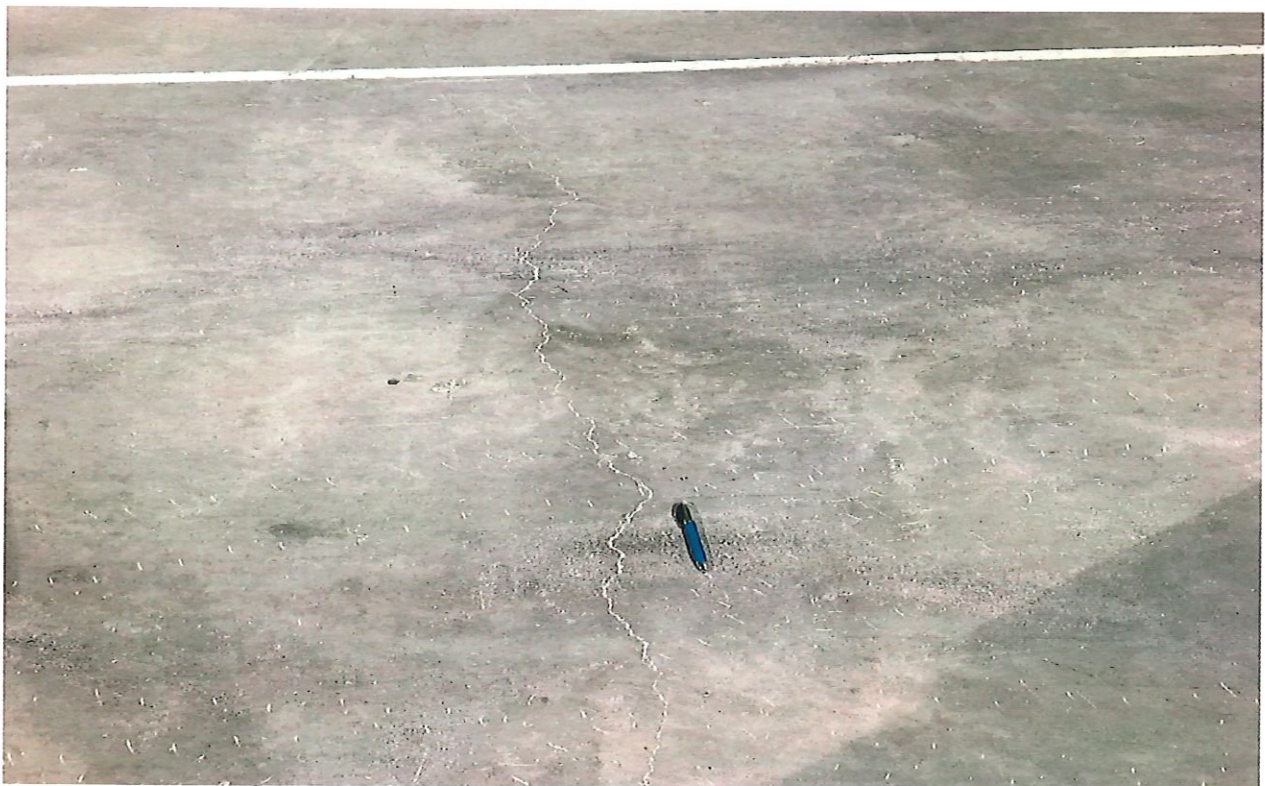
Picture #6 – Example of a shrinkage crack found in the floor

There are several small cracks in the floor, many of which look to be primarily due to the original concrete curing process (shrinkage cracks) and are not of significant concern (see picture #6). The usual guide for crack severity is measured by using the thickness of a dime. Anything thinner is not usually an issue and can simply be monitored to ensure it does not widen, while anything thicker should be addressed as soon as possible. Wider cracks can be filled with a hydraulic cementitious product in combination with a bonding agent, or injected with a rubberized epoxy.

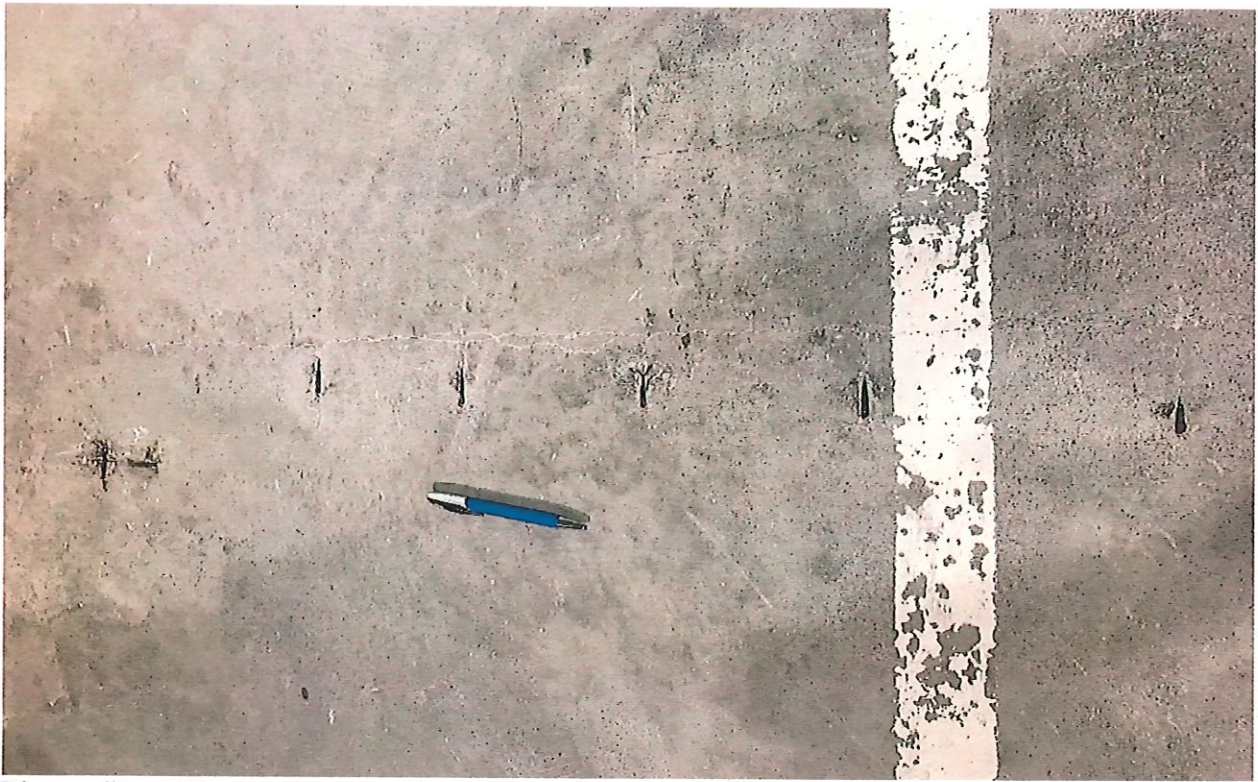
Picture #7 – Wire mesh exposed at surface of concrete

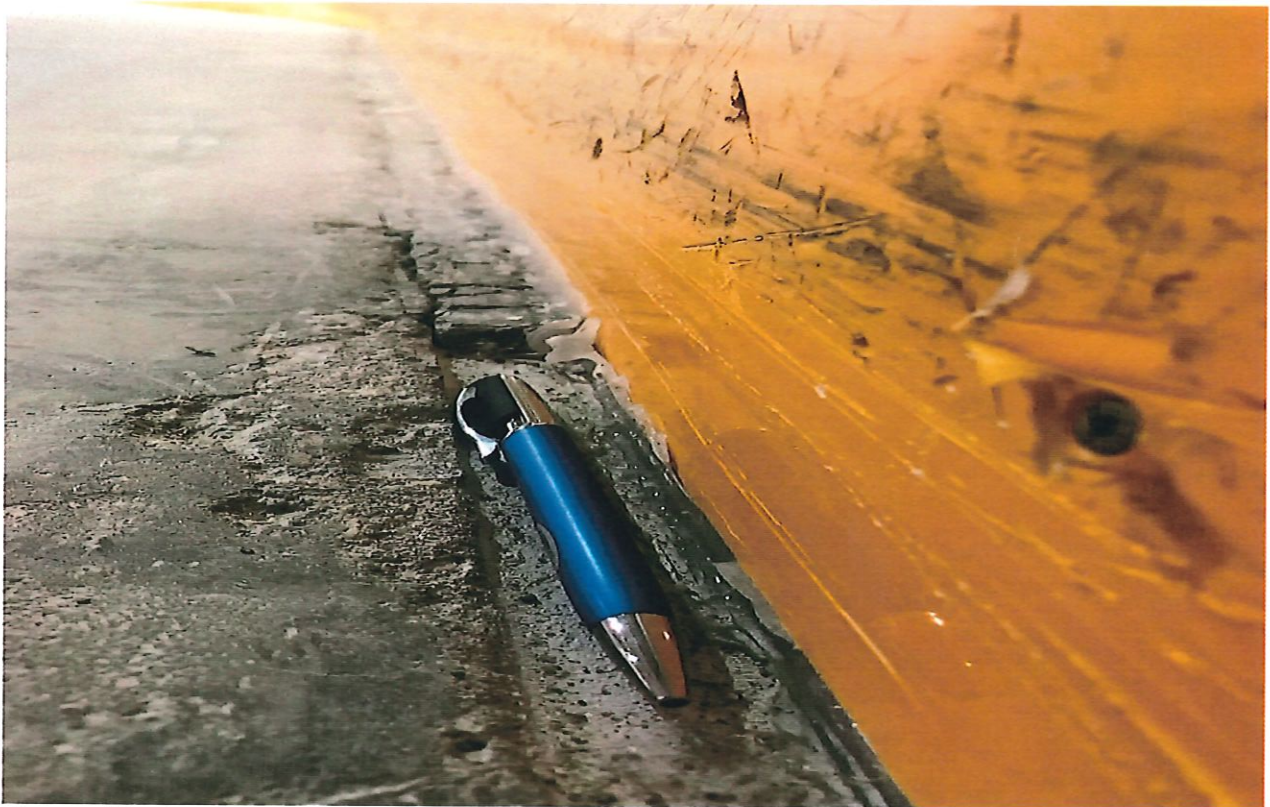
Picture #8 – Patch material on inside of dashers around perimeter of slab starting to deteriorate

There is a 1" (on average) gap around the perimeter of the slab on the inside of the dasher boards that has been patched with a cementitious product (likely grout). As it is uniform around the perimeter of the rink, and given the elevation differences found on the floor, it seems probable that the perimeter was ground down flat to accommodate a new dasher board system, and then the difference between the new boards and the old boards on the floor patched to make even. This patch is deteriorating in various places along the dasher boards as shown in picture #8 and is expected to continue as the slab ages.

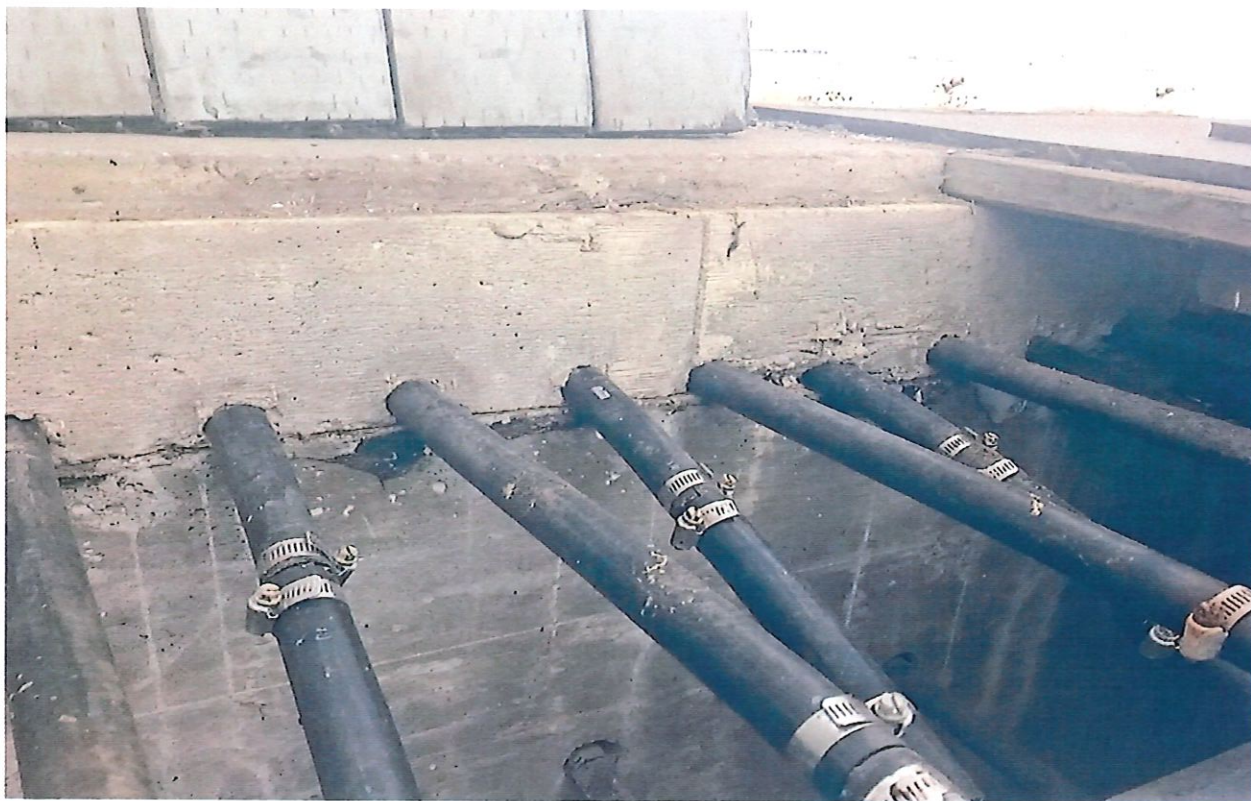
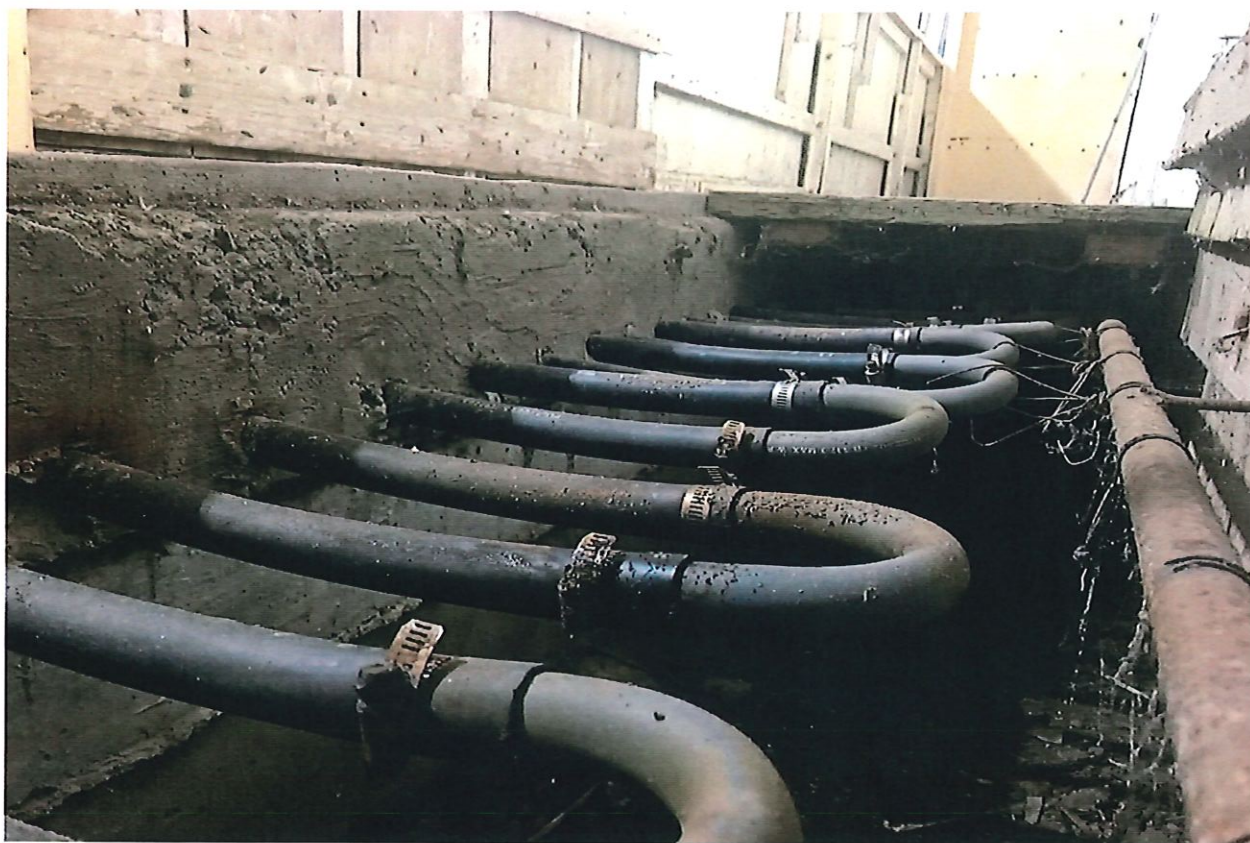
Picture #9 – Rink pipe at bottom of slab on header end

Picture #10 – Rink pipe at bottom of slab on return end

Finally, the cooling pipe seem to have been installed at the bottom of the refrigerated slab as shown in pictures #9 & #10. Today's construction practices include installing the pipe in a pipe support system so as to keep the top of the pipe approximately 1-1/2" down (on average) from top of concrete rather than 4-5" down as in this case. Similar to the additional water required on the surface, the additional concrete on top of the pipe forces the plant to work harder to cool the surface down (requiring more power) as well as requiring more time to freeze the water. This results in increased maintenance requirements, power consumption costs, and may lead to delays in games due to pooling water.

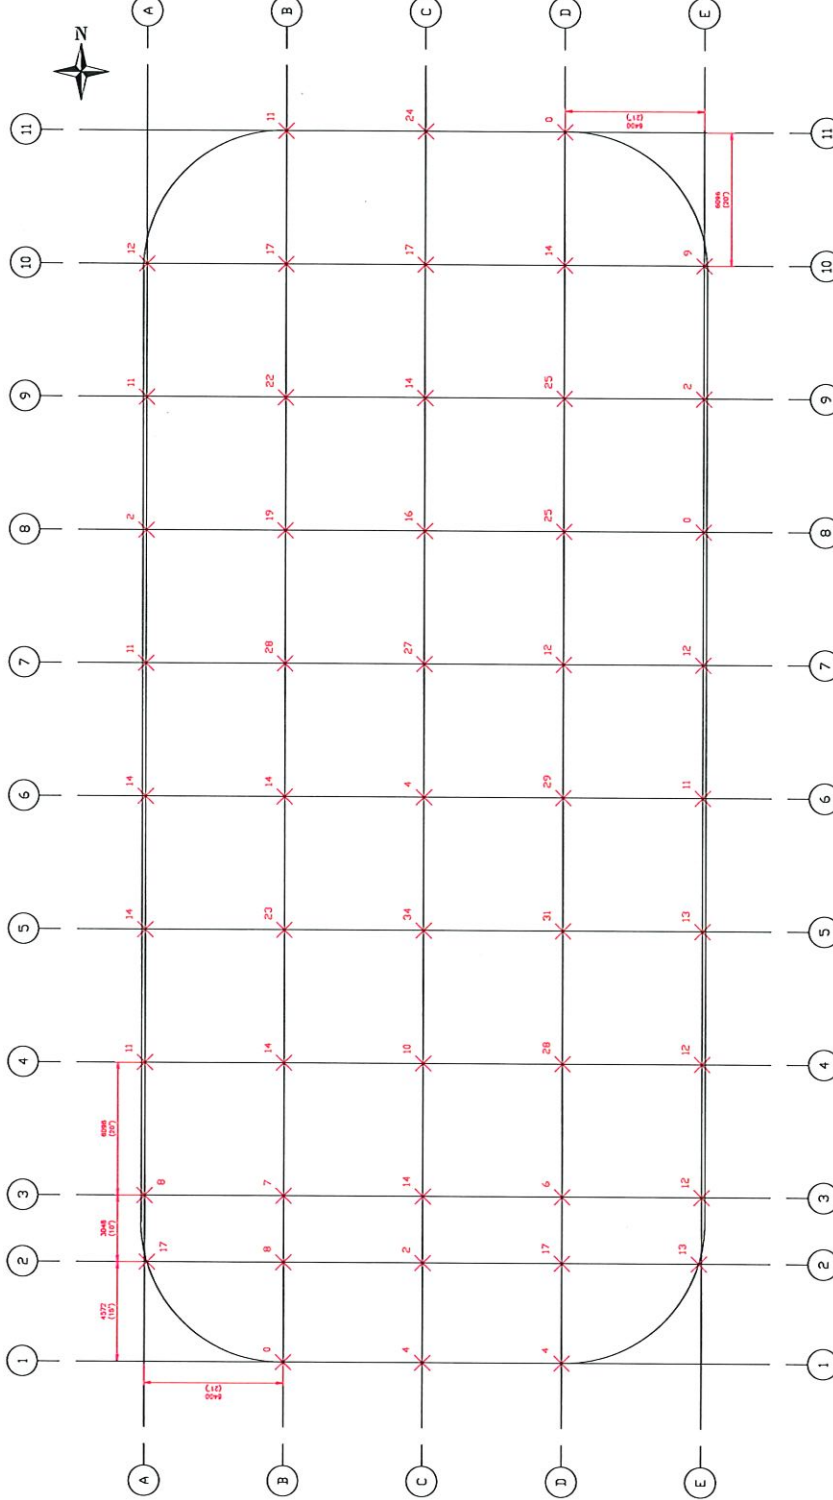
FLOOR SURVEY

BST Consulting Inc. performed a rough survey of the slab on an approximately 20' grid and confirmed there is approximately 1-1/4" variance from the highest to the lowest point on the slab. A copy of the survey is included at the end of this report for reference. The following paragraphs address the issues present with the floor in relation to the condition of the rink pipe & clamps and of the concrete slab itself.

As previously mentioned there is approximately 1-1/4" elevation variance in the floor at time of survey. The elevation variances are many and far sharper in nature than average, meaning the change from higher to lower elevation occurs in a shorter distance than for most slabs. This results in a slab that looks (from a survey perspective) a bit like an egg carton with many hills and valleys closely spaced together. This makes dry land operations less user friendly as well as increases the amount of water used to make ice under refrigerated load, thereby requiring more power from the plant to cool the brine solution in order to freeze the resulting thicker ice layer. The additional water and power requirements lead to increased maintenance costs, and require more time to make ice and to freeze "floodings" in between games. During tournament play, rapid transitions from back to back games has resulted (at least in other similar facilities) in poor performance (water pooling on slab in various areas) several minutes into each game.
